Subject: Monthly Status Report-October 2009
Fields Brook Superfund Site
Detrex Source Area-Ashtabula, Ohio

FIELDS BROOK SUPERFUND SITE, OPERABLE UNIT #2
DETREX SOURCE AREA
MONTHLY TECHNICAL STATUS REPORT

Project Phase: Remedial Design and Remedial Action.

Period: Month of October 2009.

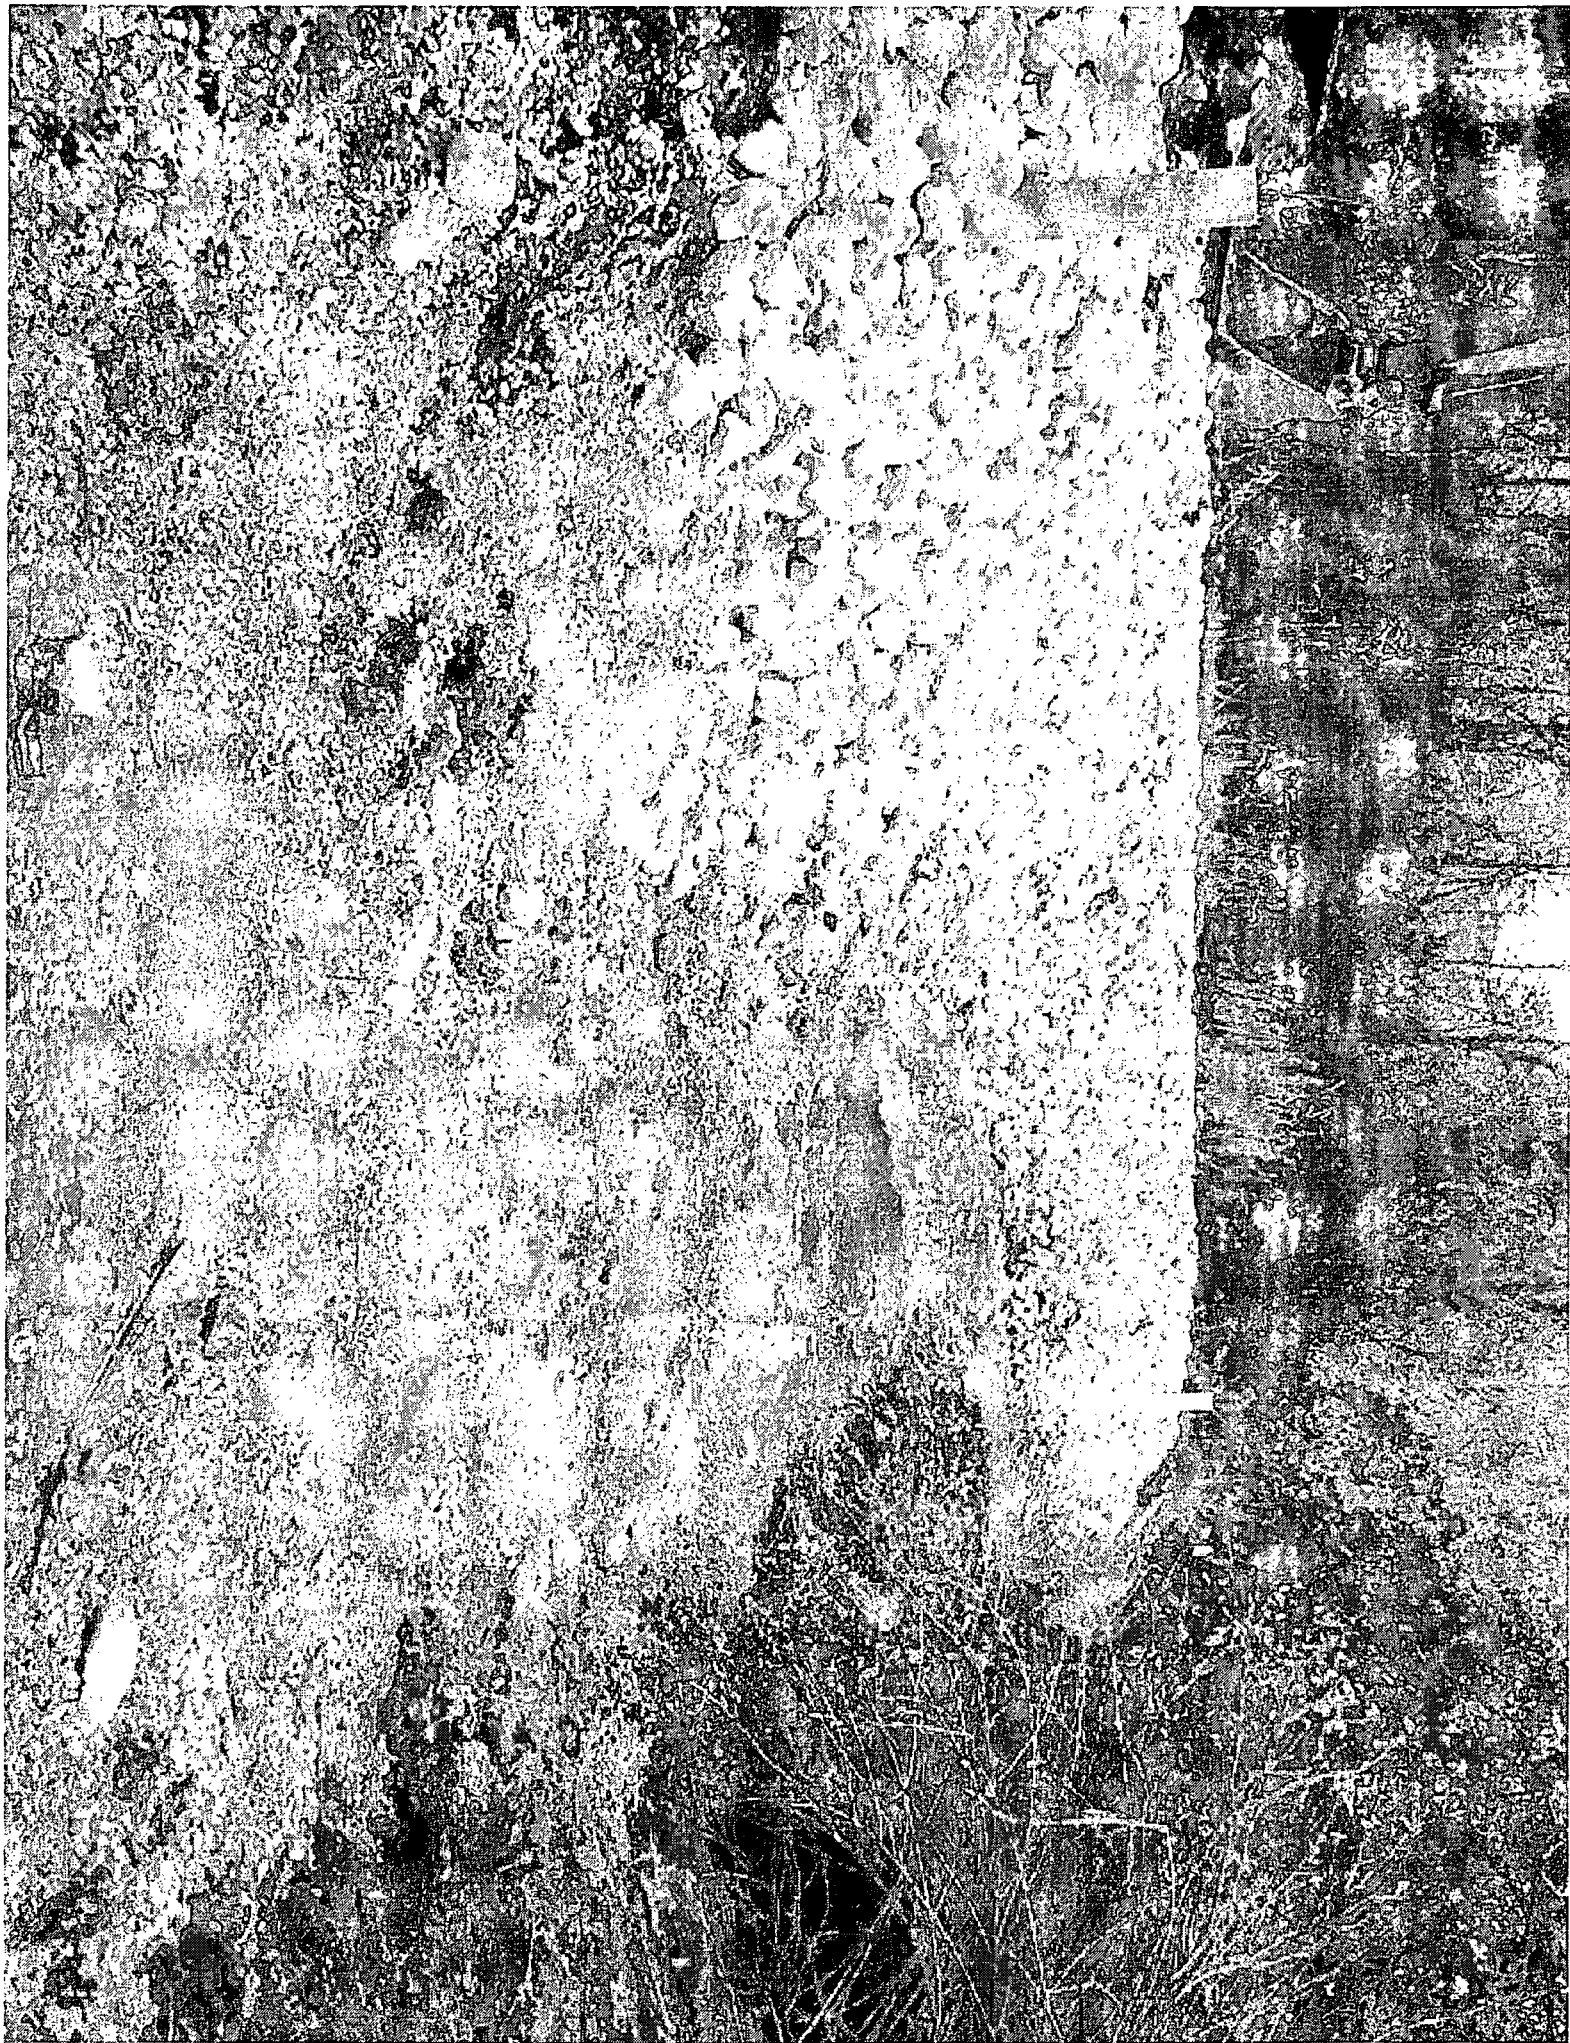
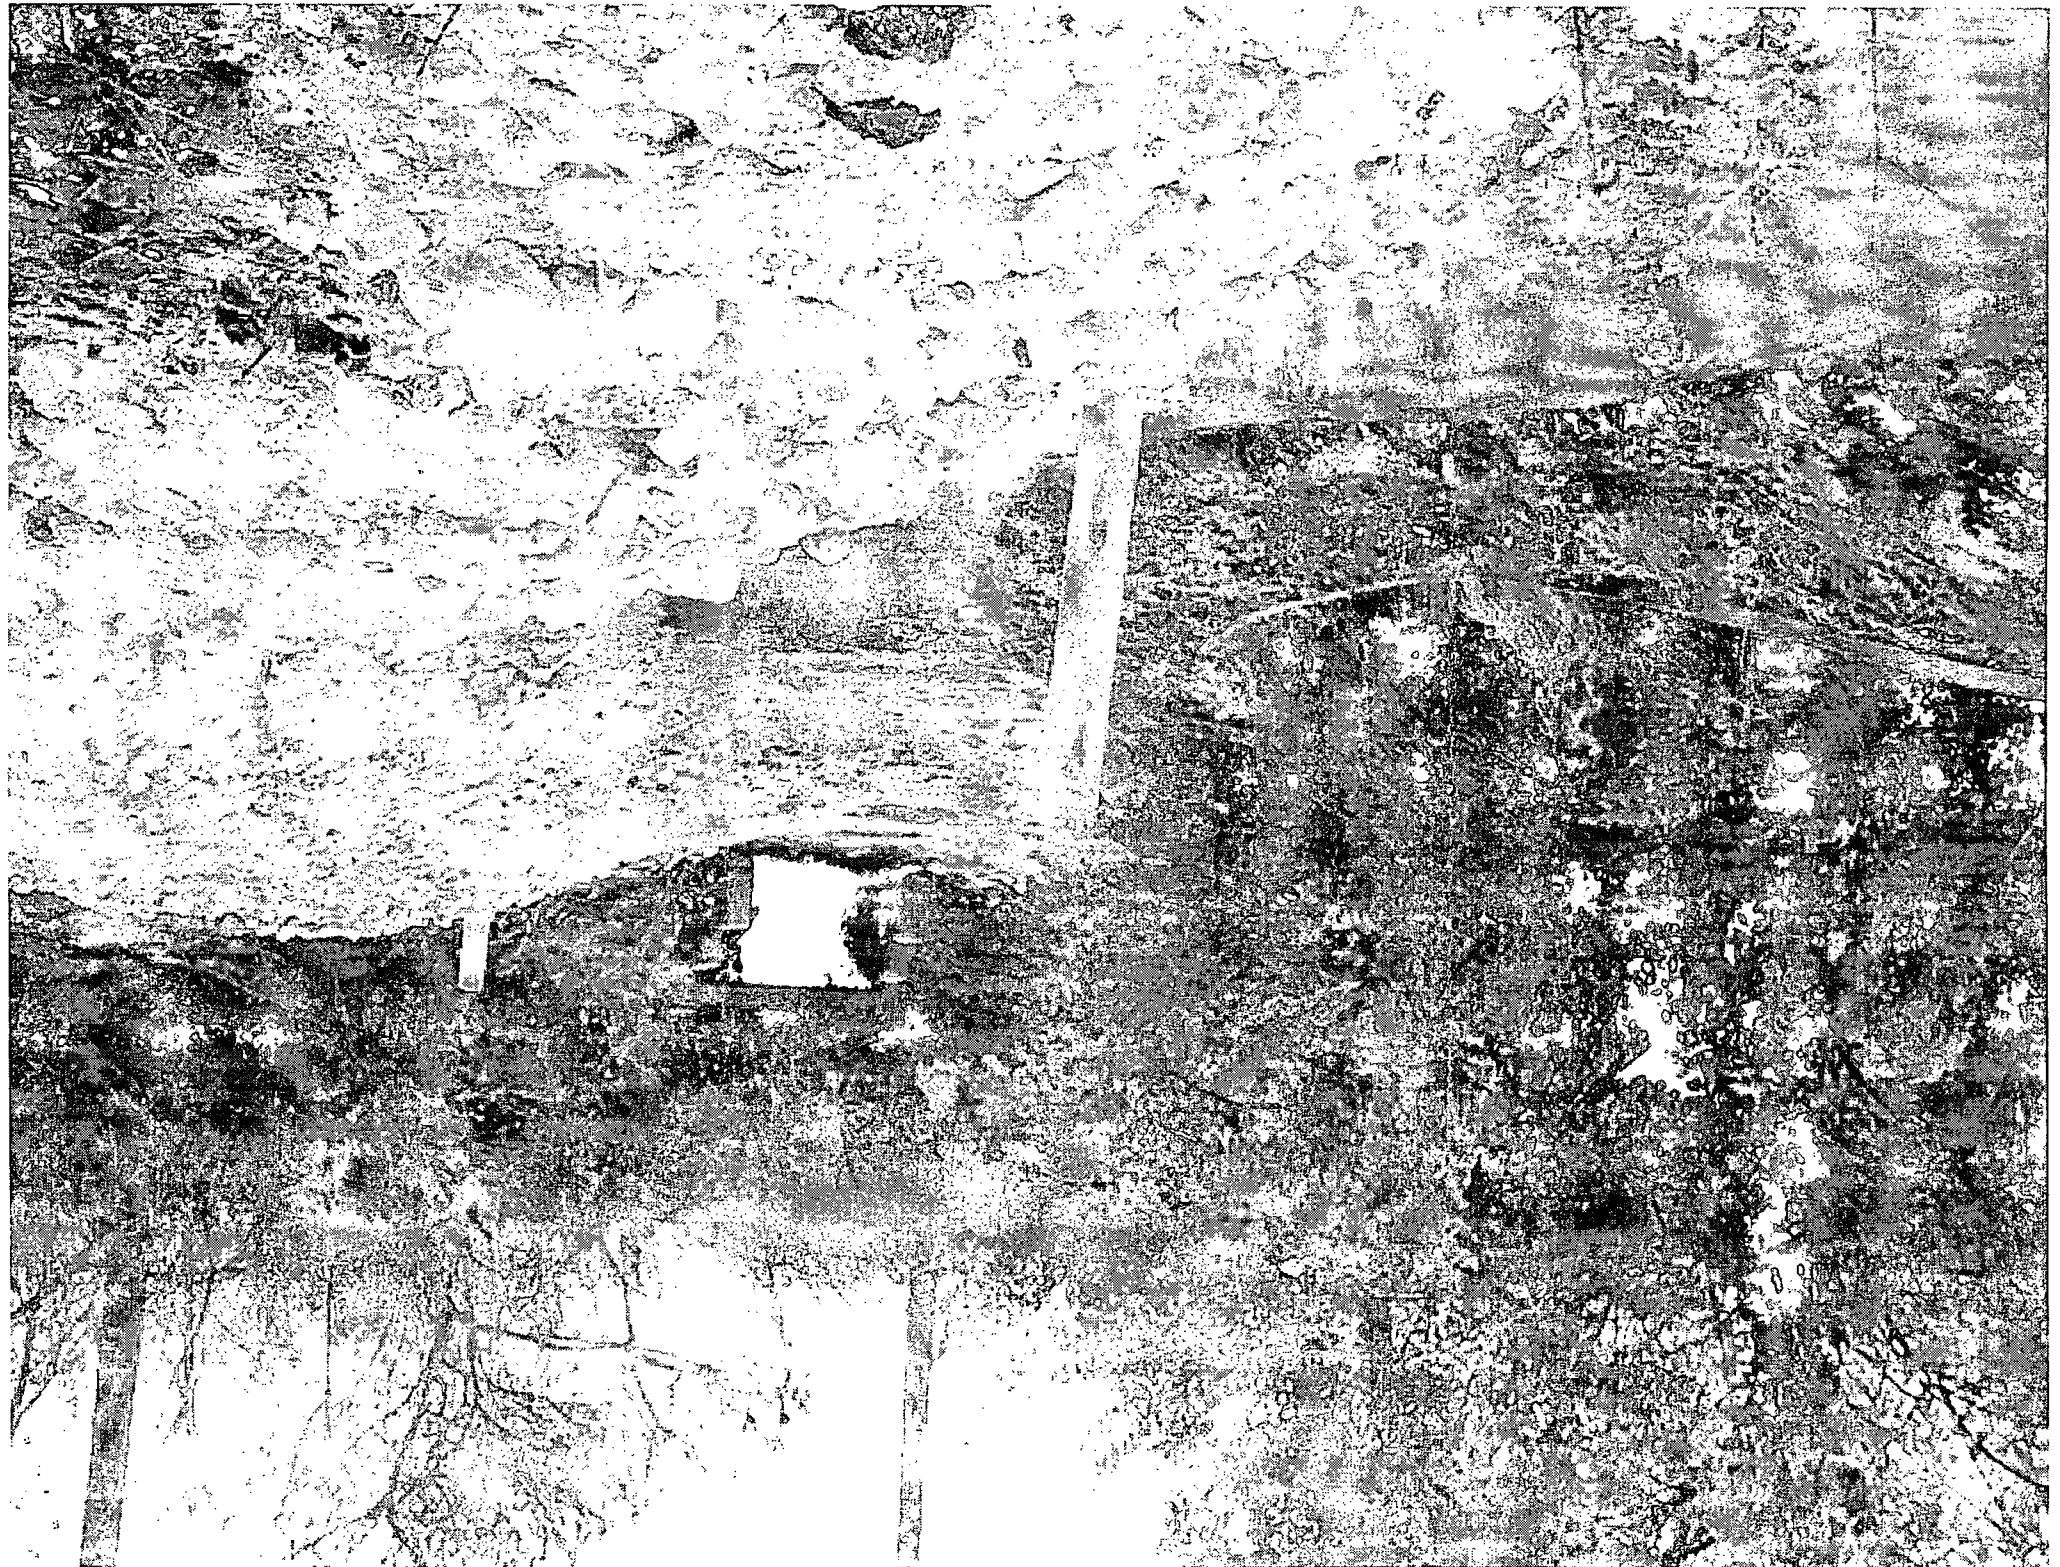
- H. The DS Tributary cleaning was completed November 10. See pictures attached. Several samples were taken along the DS Tributary. A separate report will be generated with these results.
